Manhole Inspection Summary

Manhole # S47E__020MH

Insp Date: **7/29/08 11:55 AM**

Location Address: **Baltimore**

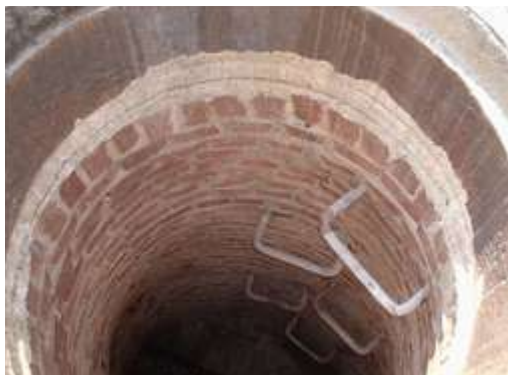
Defect 1

Infiltration: ☐ None ☐ Joint ☐ Cracks ☐ Mortar ☐ Roots ☒ **Wall**

Infiltration

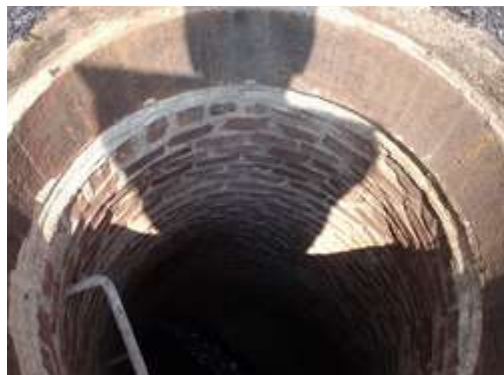
Defect 2

Frame Leaks

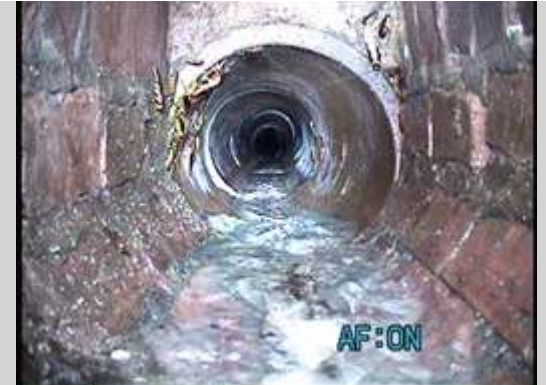
12 O'Clock Outflow

8 in. Circular Gravity Sewer
Pipe Out @ 12 O'Clock

Pipe Height: **8.4** (in.) Rod and Bar (Angled)
Pipe Material: **Clay** ☐ Pipe Lined
Invert Depth: **9.90** (ft.) Flow Characteristics: **Fast**
Deposits: ☒ None ☐ Mud ☐ Sludge ☐ Debris ☐ Grease
Silt Depth: (in.) Deposits Extent:
Infiltration: **None** Pipe Seal Cond: **Sound**

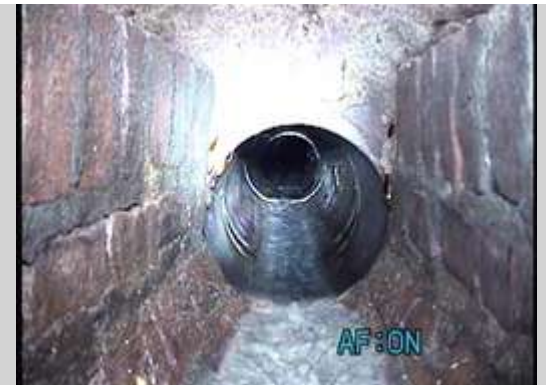
6 O'Clock Inflow

8 in. Circular Gravity Sewer
Pipe In @ 6 O'Clock

Pipe Height: **8.4** (in.) Rod and Bar (Angled)
Pipe Material: **Clay** ☐ Pipe Lined
Invert Depth: **9.95** (ft.) Flow Characteristics: **Fast**
Deposits: ☒ None ☐ Mud ☐ Sludge ☐ Debris ☐ Grease
Silt Depth: (in.) Deposits Extent:
Infiltration: **None** Pipe Seal Cond: **Sound**
